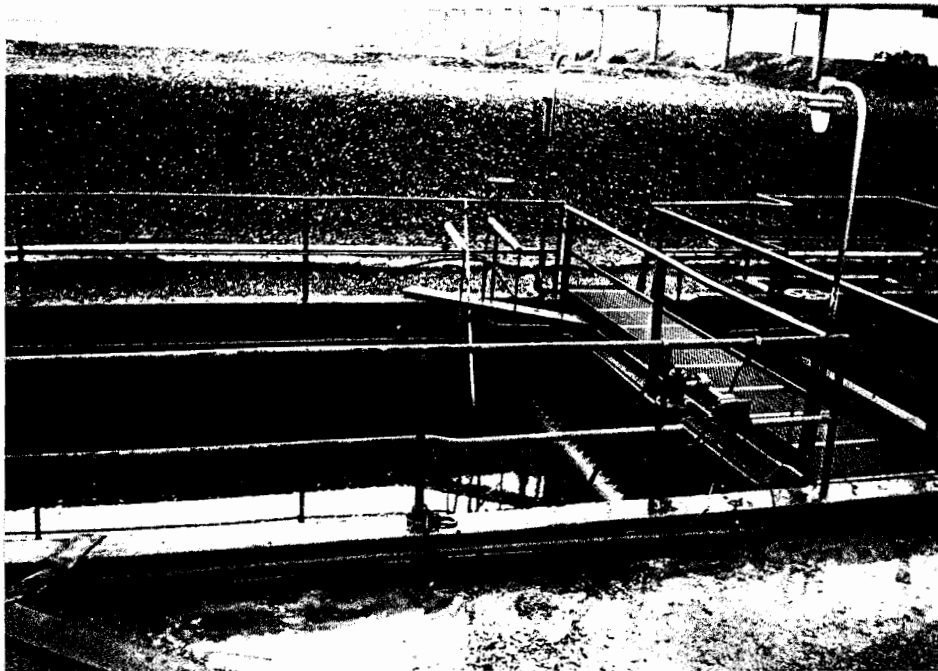
63.1 1A Oil/Water Separator. View facing east toward the middle section of the separator. Note the oily accumulation on the soil around the unit.

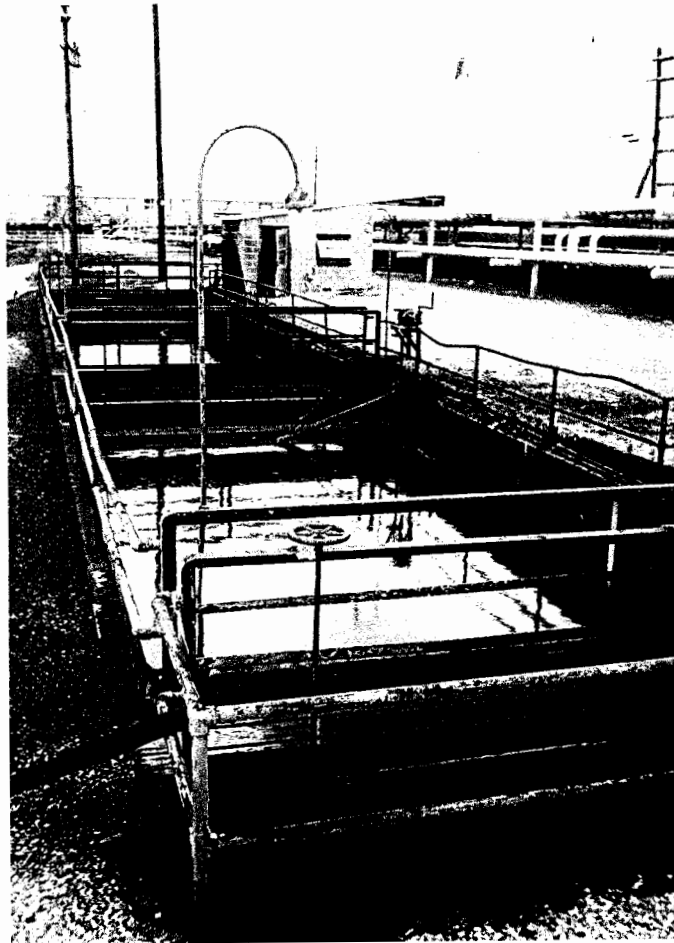
65.1 1C Oil/Water Separator. View facing south. Note the heavy staining on the unit and surrounding areas.

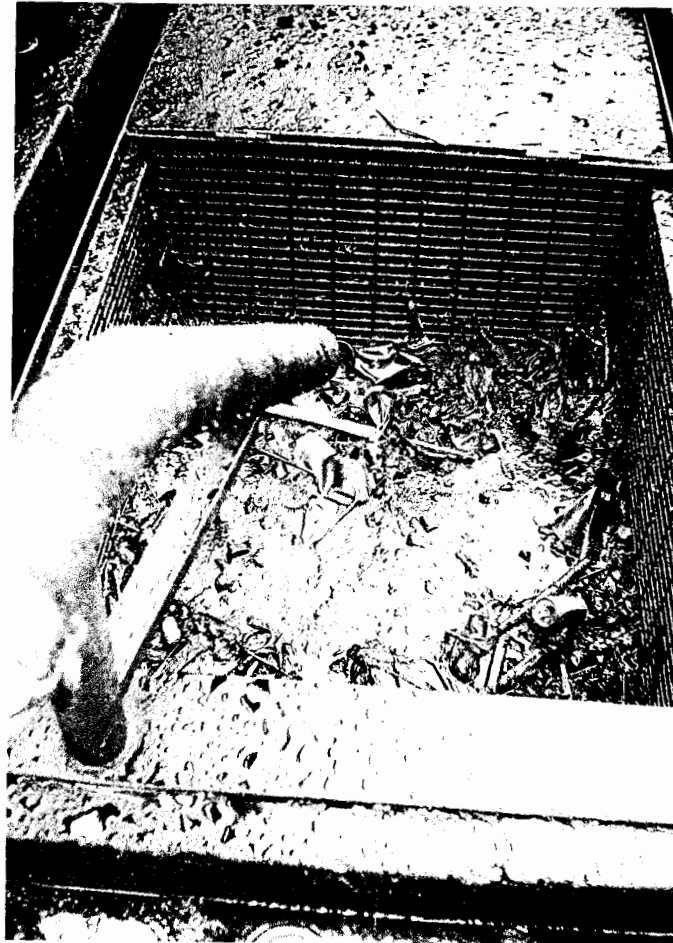
66.2 1D Oil/Water Separator. Close-up view of strainer at the north end of the separator. Note the oil saturated condition of the debris collected in the screen area.

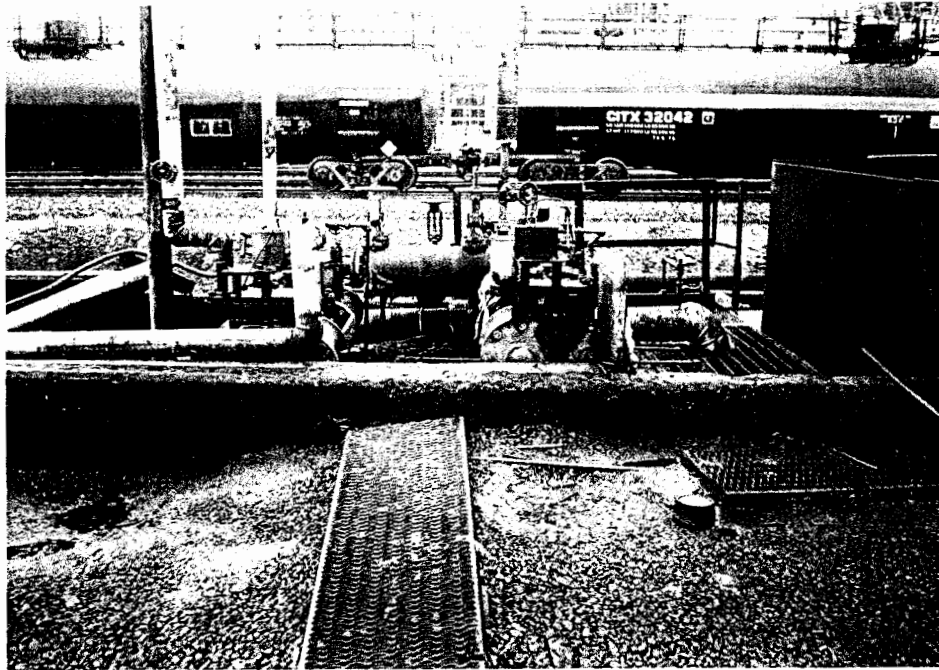
66.4 1D Oil/Water Separator. View facing south toward the pump system for the separator. Note the heavy oil accumulation.

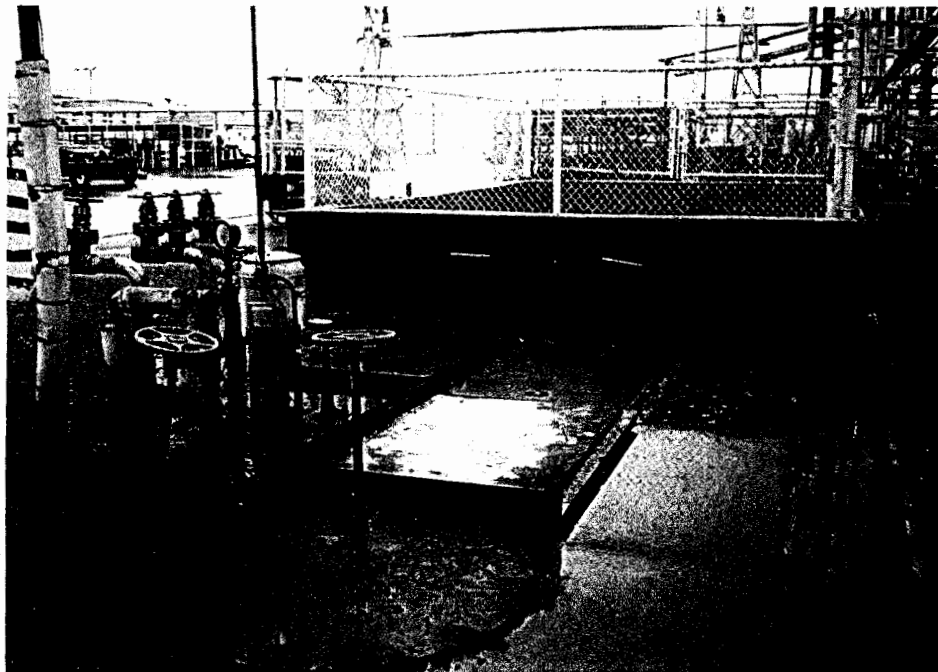
68.1 1F Oil/Water Separator and 1F Oil/Water Separator Electrical
G.1 Box. View facing east. The separator system involves the valves and pumps in the photograph. The fenced concrete box is the 1F Oil/Water Separator Electrical Box (AOC G).

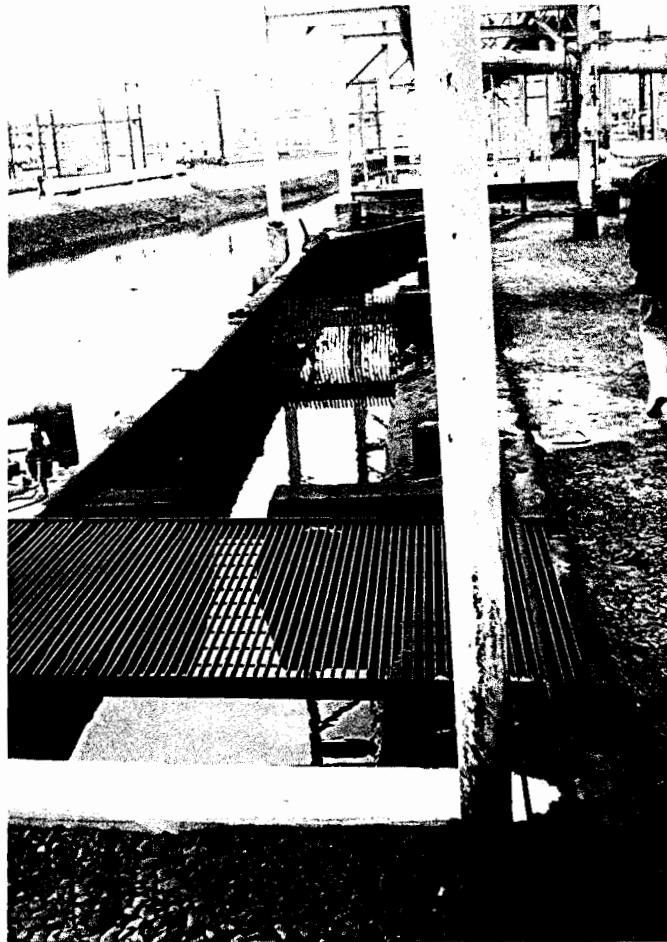
69.1 1F Oil/Water Separator Feed Trench. View facing west toward
the open end of the feed trench near the weir.

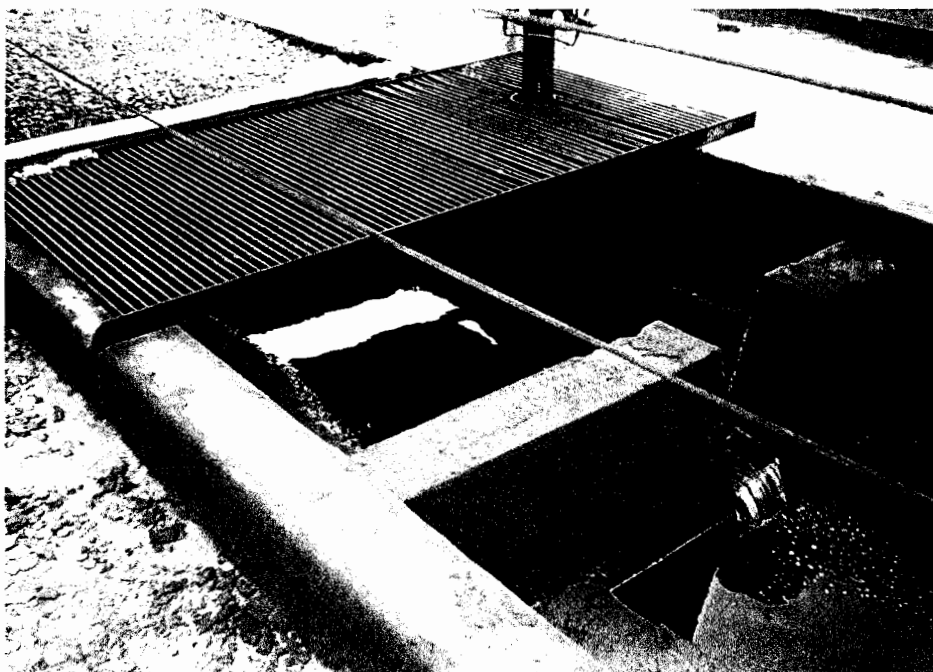
69.2 1F Oil/Water Separator Feed Trench. Close-up view facing east toward the weir in feed trench. Note the oil accumulation surrounding the unit.

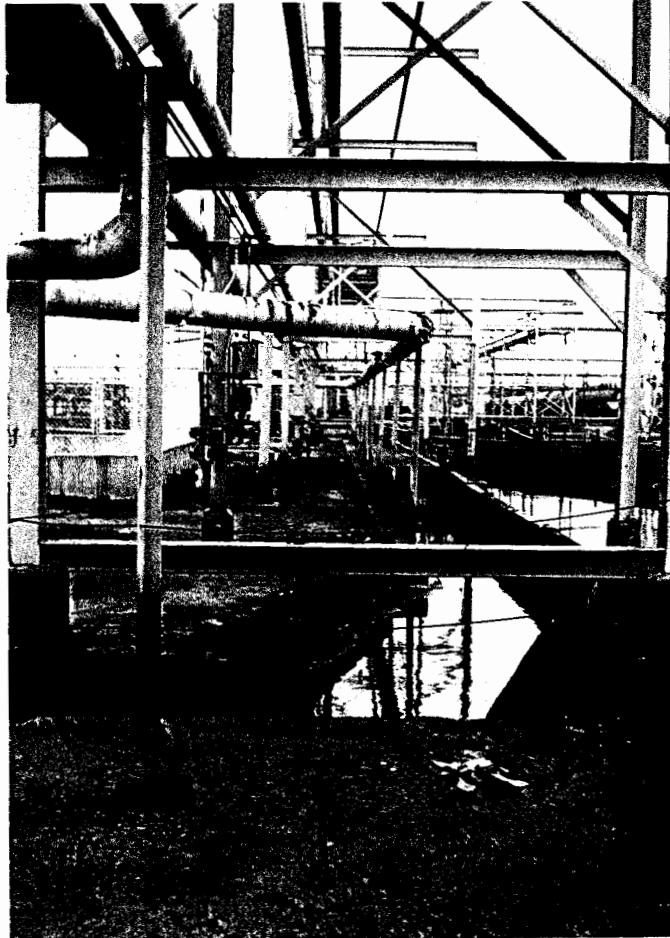
69.3 1F Oil/Water Separator Feed Trench. View facing east. The Middle Creek Surface Drainage System (SWMU 96) is visible to the right of the feed trench.

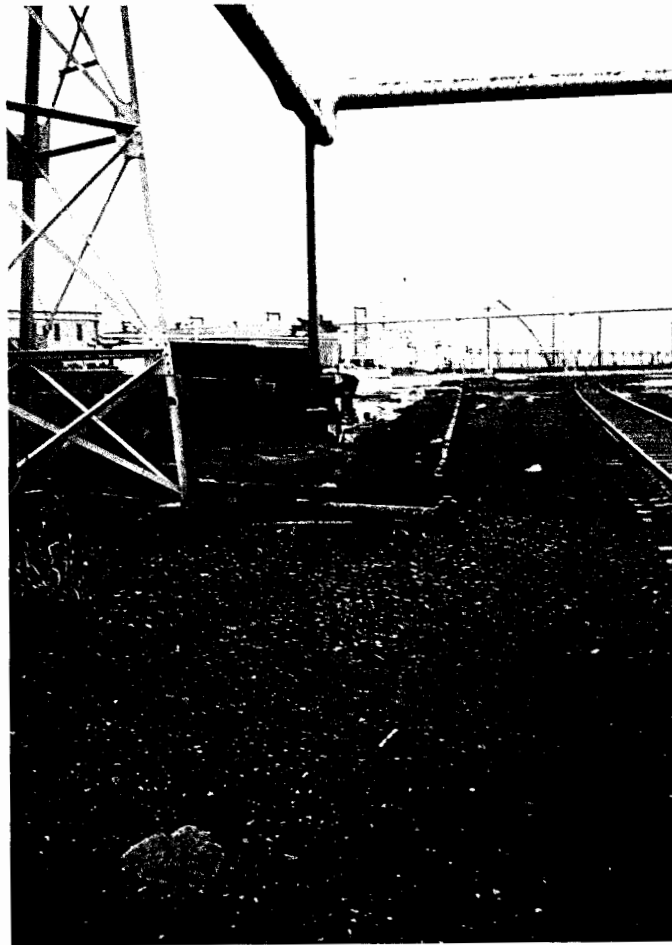
69.4 1F Oil/Water Separator Feed Trench. View facing northeast
in the area of the underground pipe line which feeds into
the feed trench for the 1F Oil/Water Separator (SWMU 68).
The pipe line runs parallel to the railroad tracks.

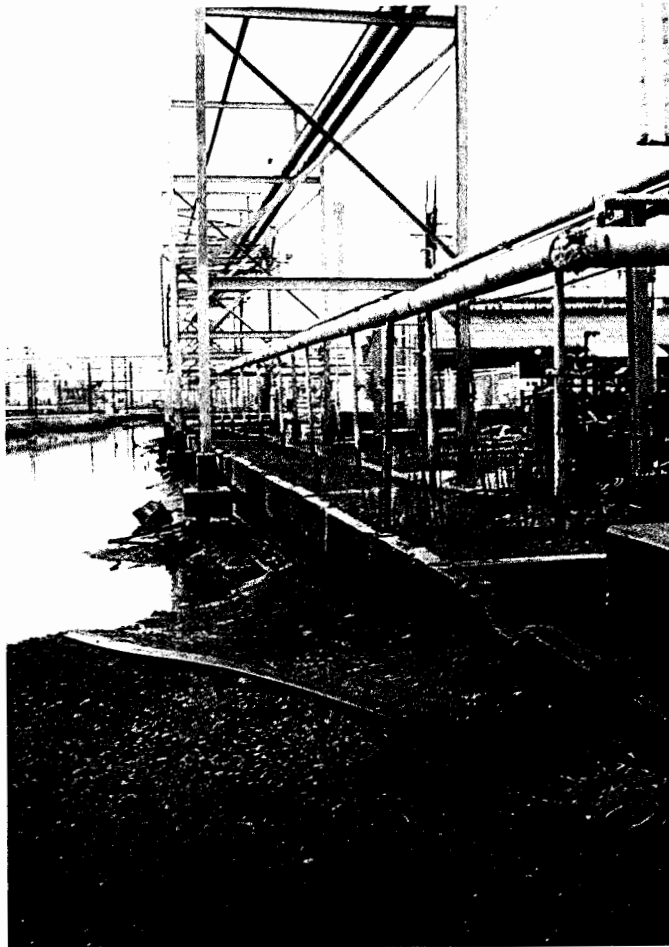
69.5 1F Oil/Water Separator Feed Trench. View facing northwest. The concrete area has an underground pipe which leads east to an open trench (dark stained area to the right). The Middle Creek Surface Drainage System (SWMU 96) is visible to the left in the photograph.

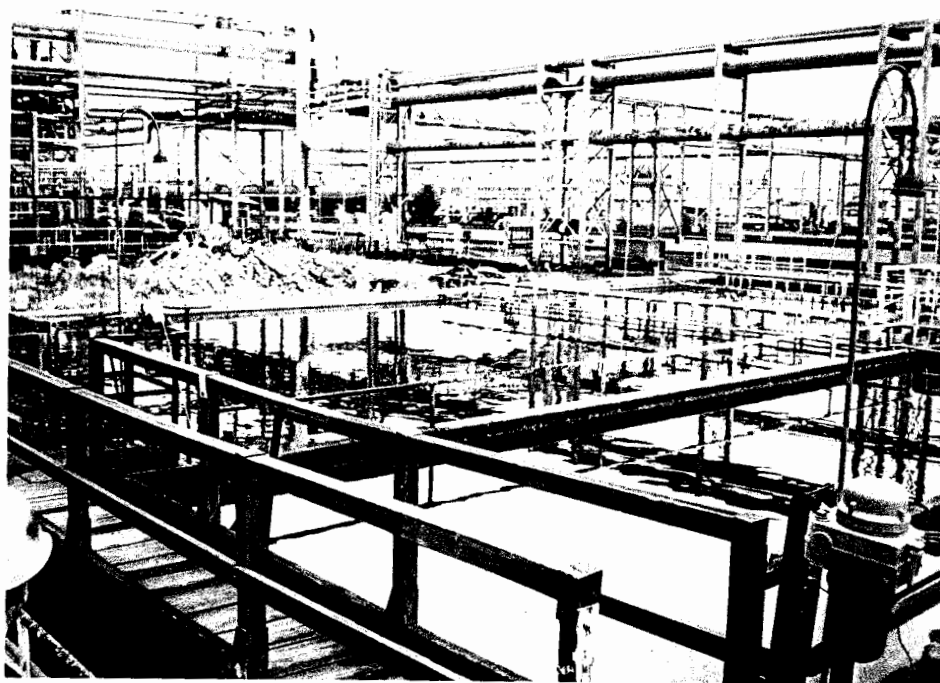
70.3-79.3 9 and 14 Oil/Water Separators. View facing west to northwest. The rubble pile at the west end of the separators is the demolished portion of 9 Separator.

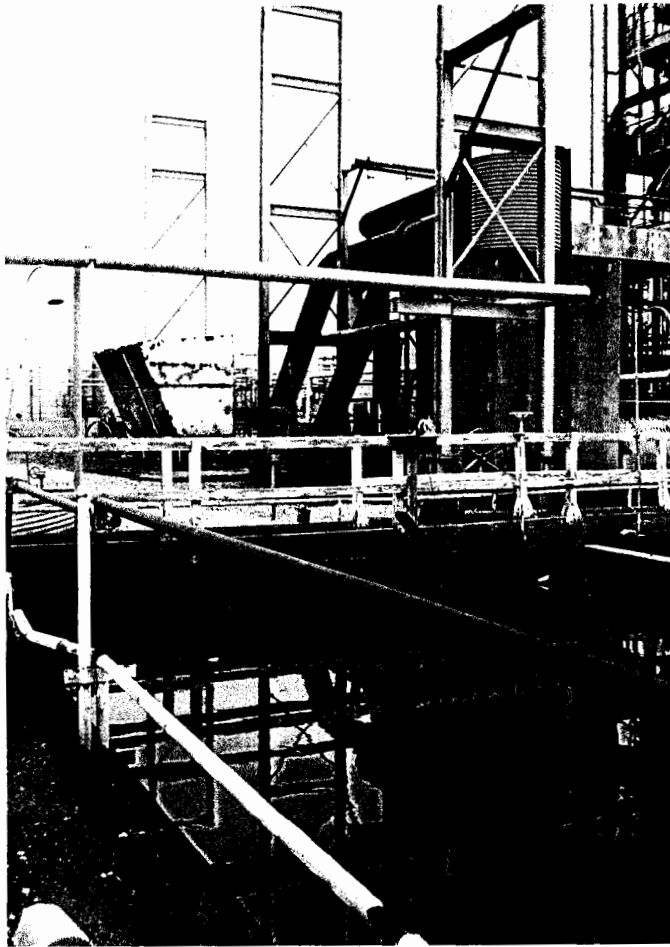
70.4-79.4 9 and 14 Oil/Water Separators. View facing south toward the water pump and outfall pipe at the east end of the separators. This pump is primarily associated with the 14 Separator.

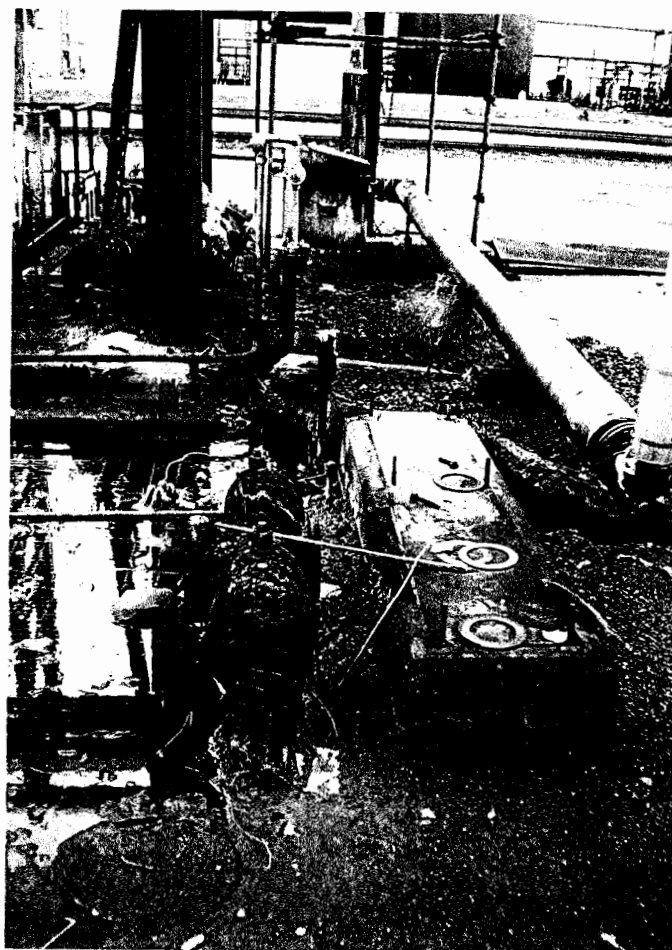
70.5-79.5 9 and 14 Oil/Water Separators. Close-up view of valves for the oil pump at east end of the separators. Note the heavy staining in the area.

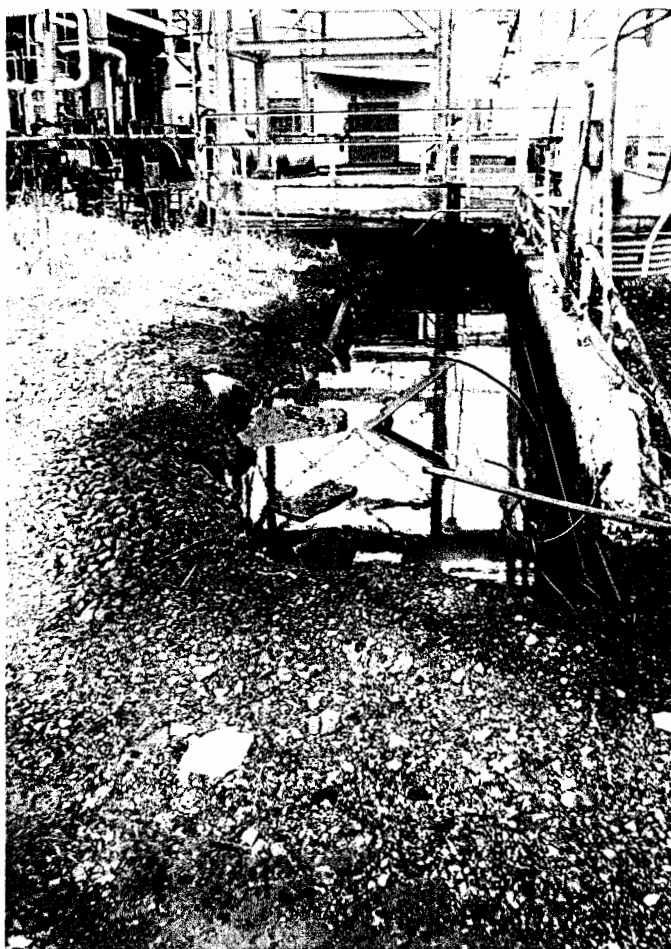
70.6-79.6 9 and 14 Oil/Water Separators. View facing west toward west end of the 9 Separator showing the demolished compartments 9A, 9B, and 9C. Note the heavy oily accumulation.

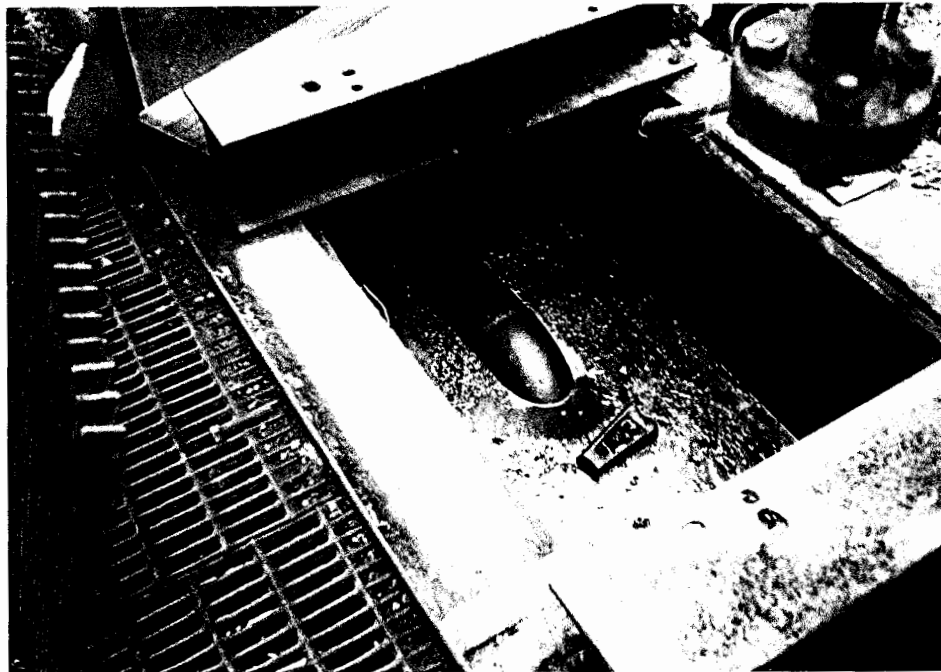
70.8-79.8 9 and 14 Oil/Water Separators. Inside view of the valve box at the west end of the 9 Separators. Note oily material which is approximately 2-3 feet deep in the valve box.

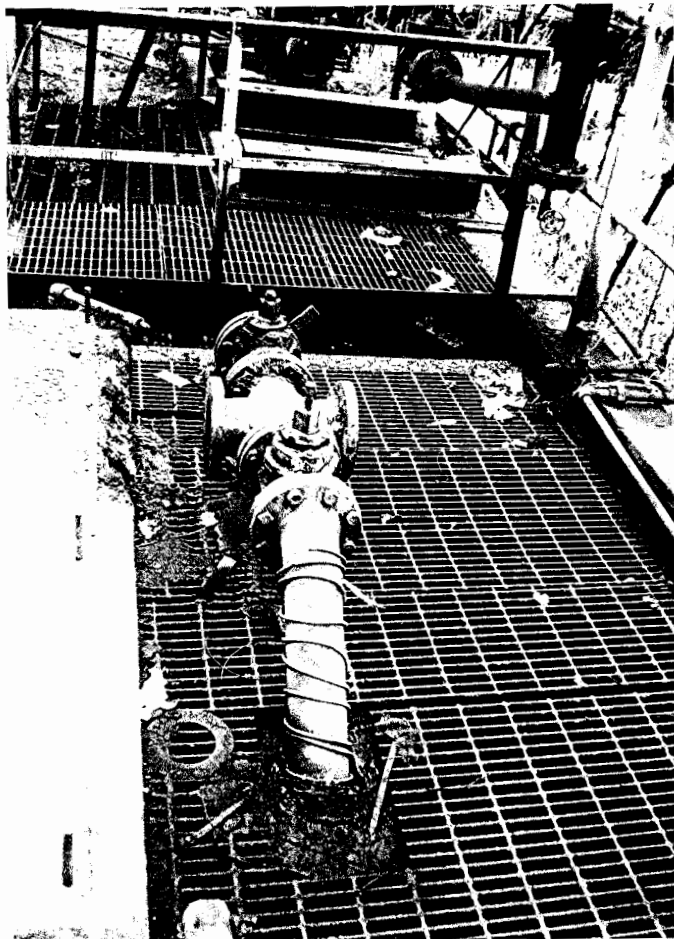
70.9-79.9 9 and 14 Oil/Water Separators. View of grated pump area at west end of the 9 Separator showing water contained beneath grated area.

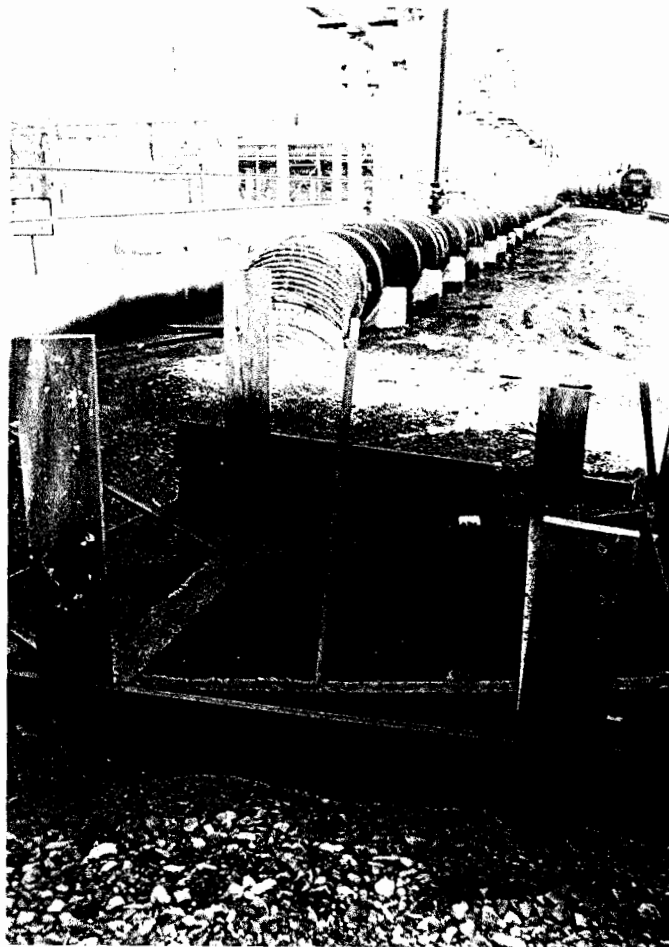
- 80.1 Discharge Pipe and Excavation at 9 and 14 Oil/Water Separators. View facing west toward a wastewater line (the large black corrugated pipe), through which the effluent from the 9 and 14 Oil/Water Separators (SWMUs 70 - 79) flowed to the Middle Creek Surface Drainage System (SWMU 96). The excavation pit in the foreground has been abandoned. Note the heavy staining along the pipeline and surrounding the pit. The pit is approximately eight feet square and could be as deep as ten feet.

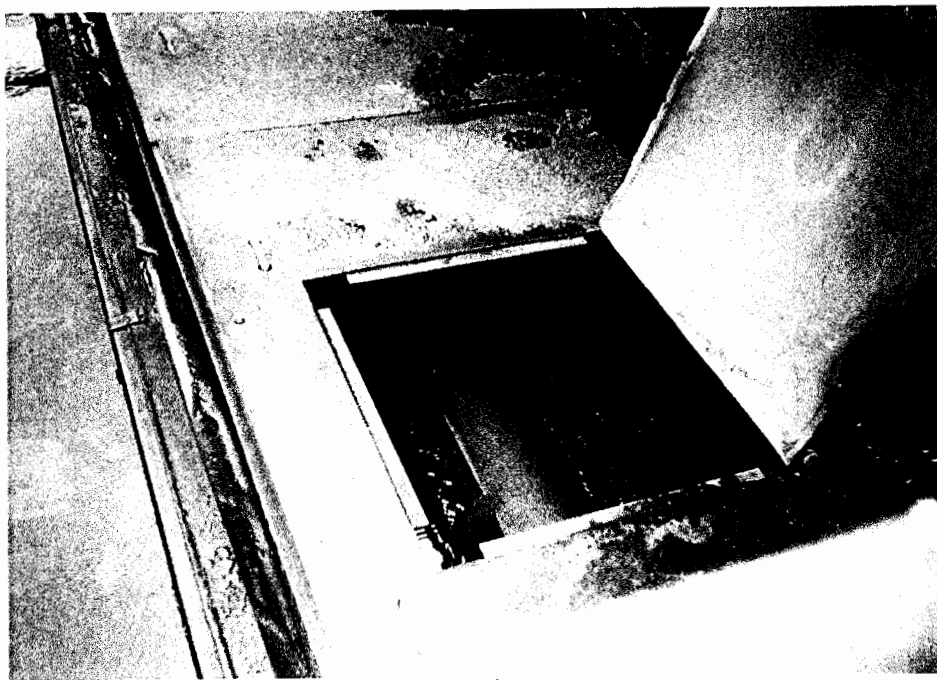
81.3 10 Oil/Water Separators. Close-up view facing east and down
 82.3 into the end compartment of the unit. The pipe shown is an
 adjustable skimmer. Note the oily emulsion in the water.

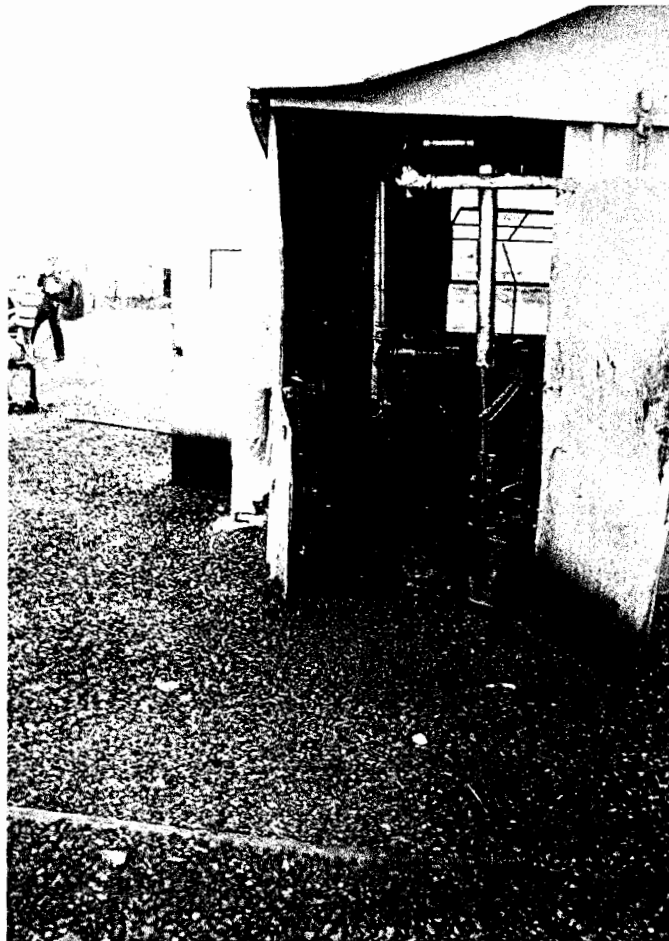
81.5 10 Oil/Water Separators. View facing east toward pump house
82.5 adjacent to the separator. Note heavy staining on building
 and surrounding ground surface. The floor (ground surface)
 of the pump house is saturated with oil.

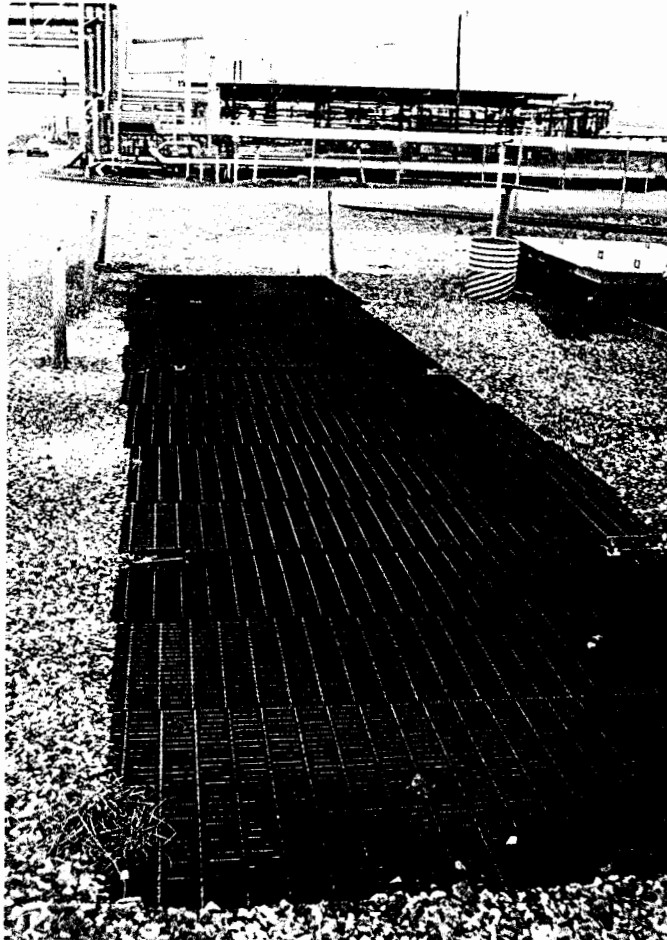
83.1 12A Oil/Water Separator. View facing west of the outfall
area for the separator.

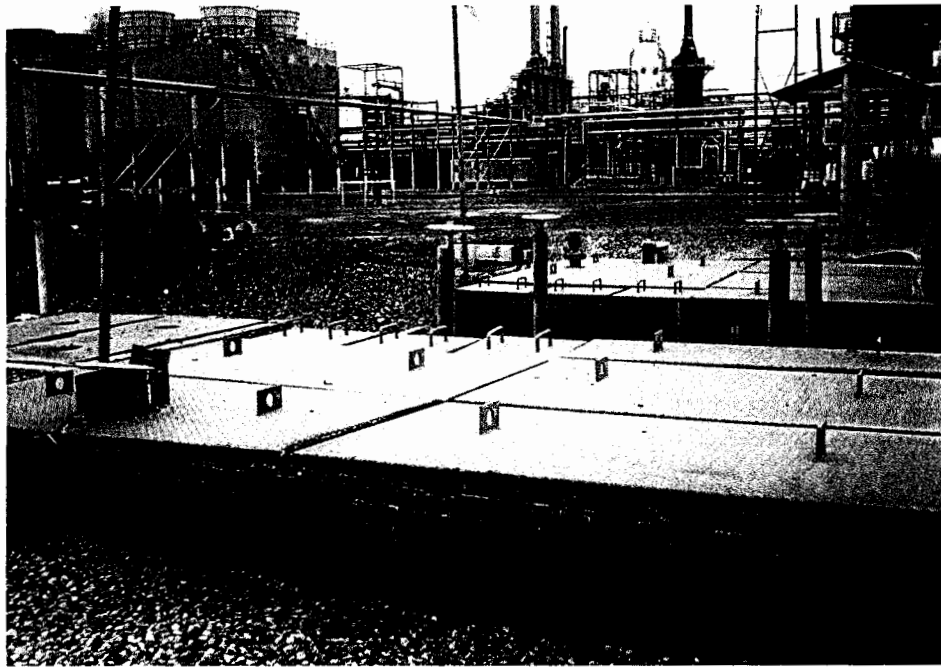
83.2 12A Oil/Water Separator. View facing east of the inlet area of the separator. The unit is underground, beneath the metal compartments shown in the photograph.

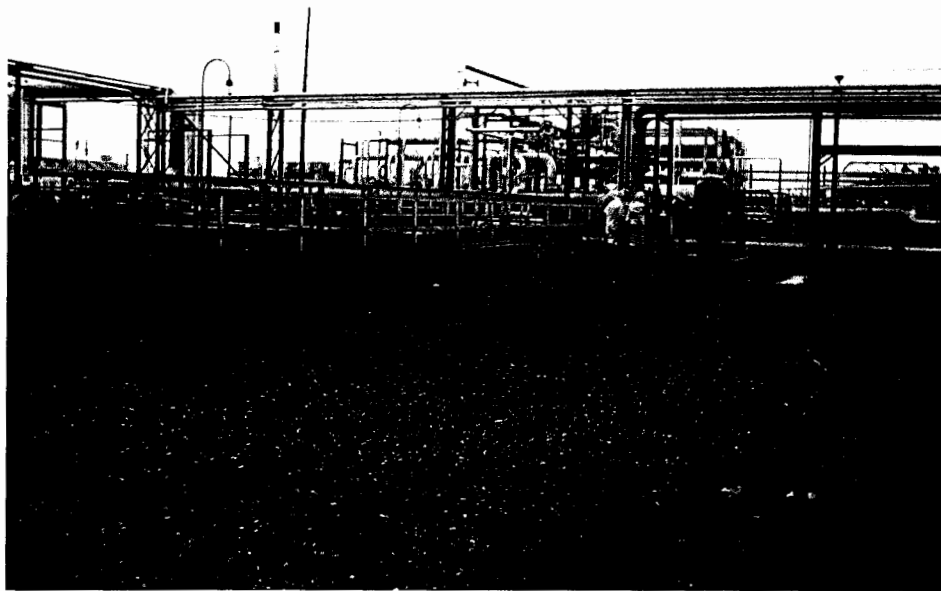
84.1 16 Oil/Water Separators. View facing south. The water pump
85.1 for the unit is the large green device to the right of the
86.1 unit.

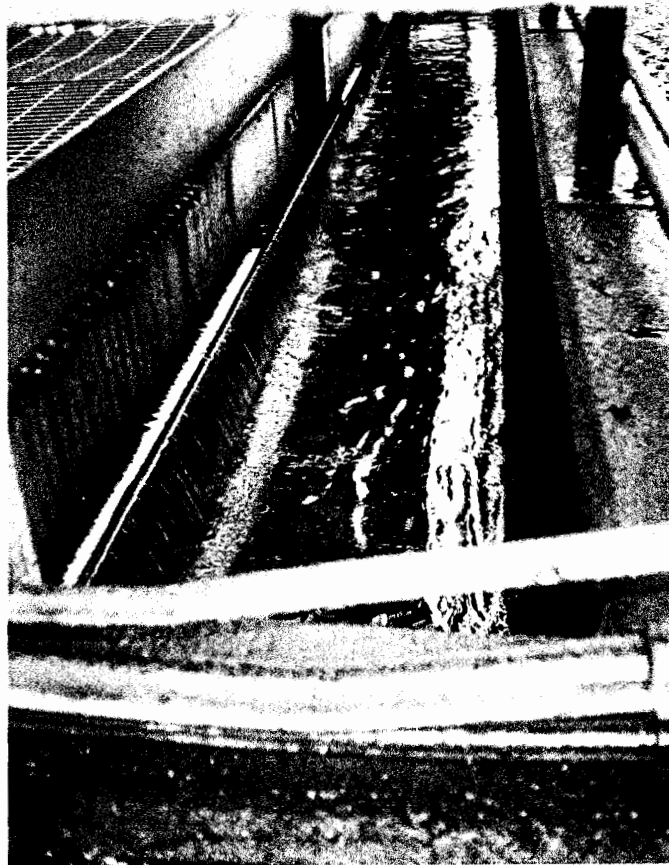
84.2 16 Oil/Water Separators. Close-up view of the weir
85.2 mechanism at the north (discharge) end of the unit. Note
86.2 the oil build-up on the concrete surrounding the weir.

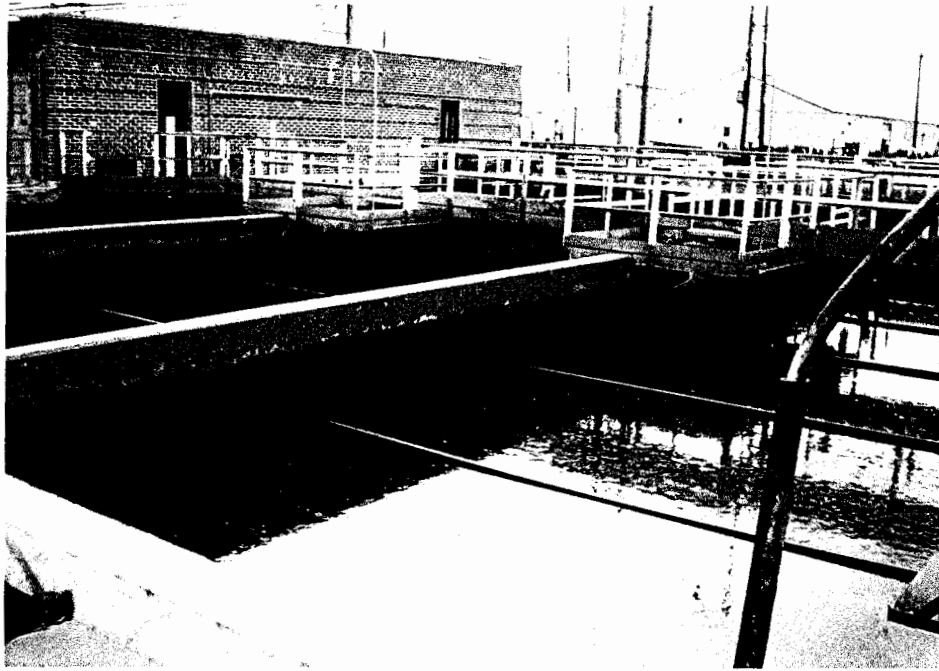
84.3 16 Oil/Water Separators. Close-up view of the 16A, 16B, and
85.3 16C separators.
86.3

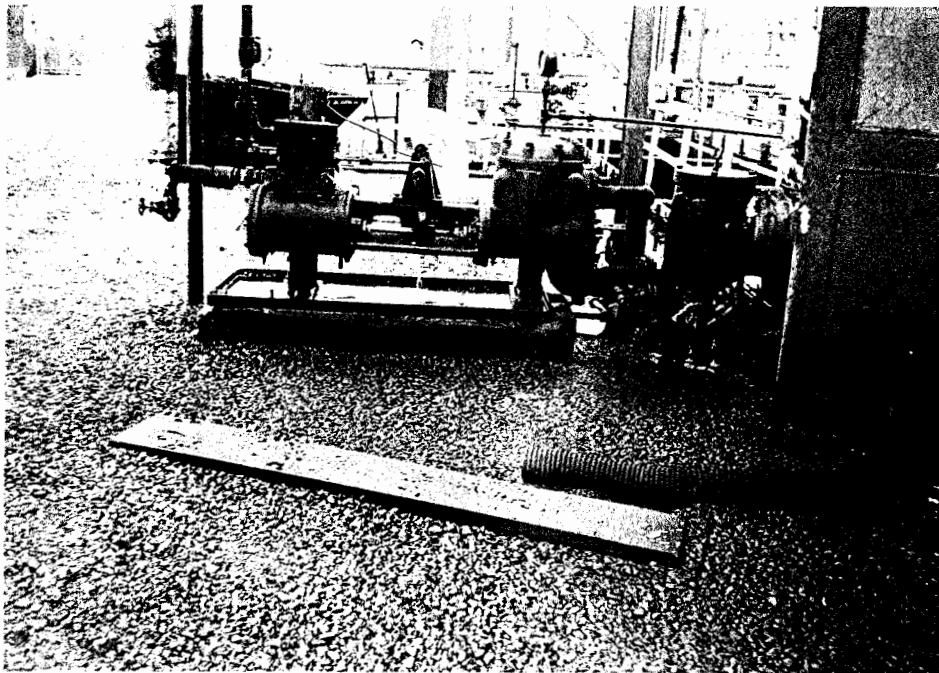
84.4 16 Oil/Water Separators. View facing west toward pump at
85.4 the south end of the separator. Note the oil saturated
86.4 gravel surrounding the pump.

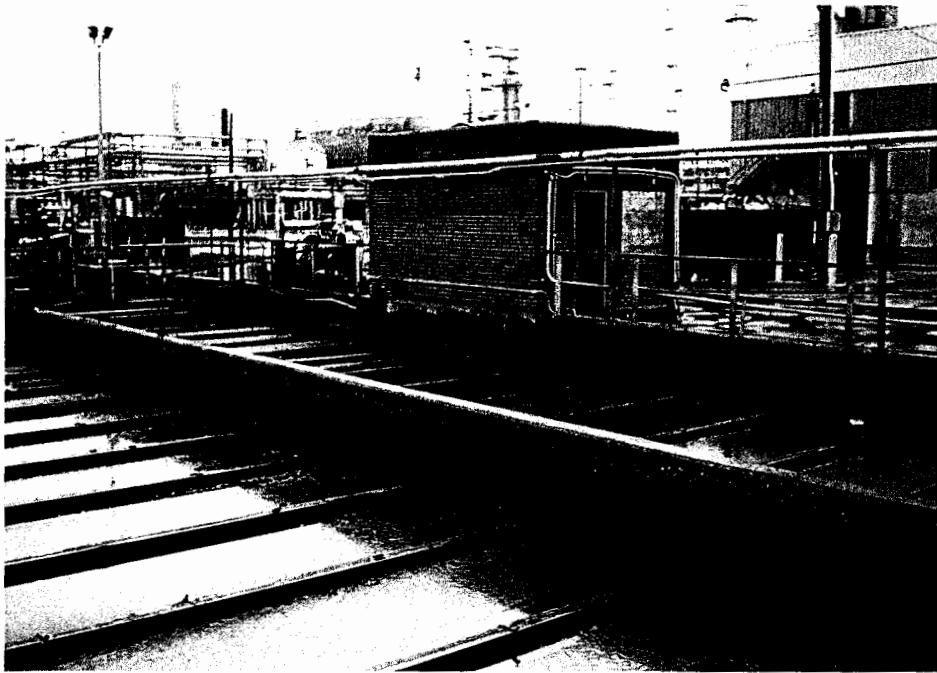
87.1-94.1 15 Oil/Water Separators. View facing northeast toward the east end of the separator. Note the oil accumulation in the unit.

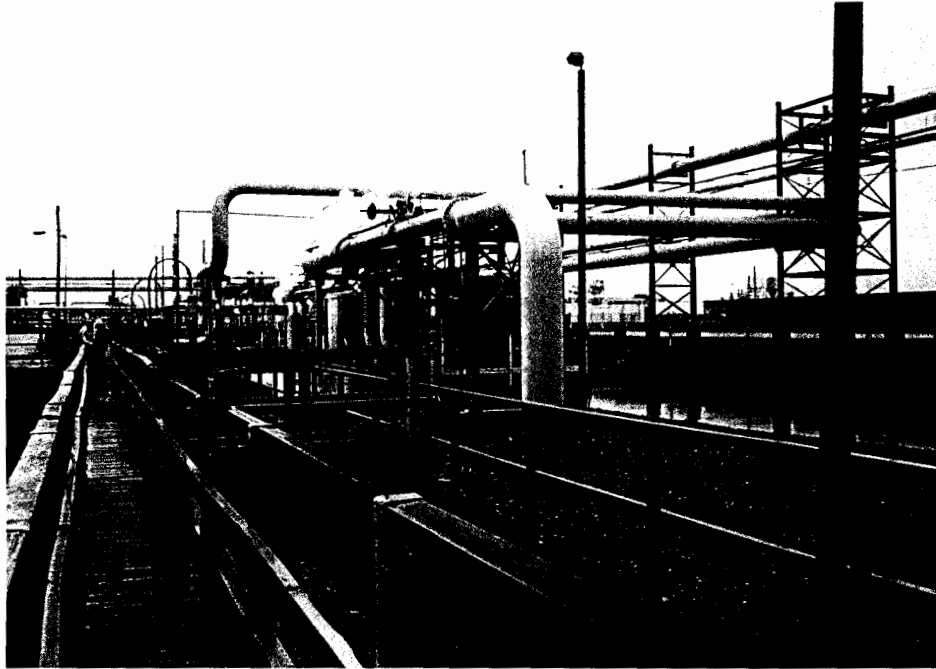
87.3-94.3 15 Oil/Water Separators. View facing east toward the south end of the separator. The Middle Creek Surface Drainage System (SWMU 96) and pipes (white) leading to DELCORA are visible to the right of the separator.

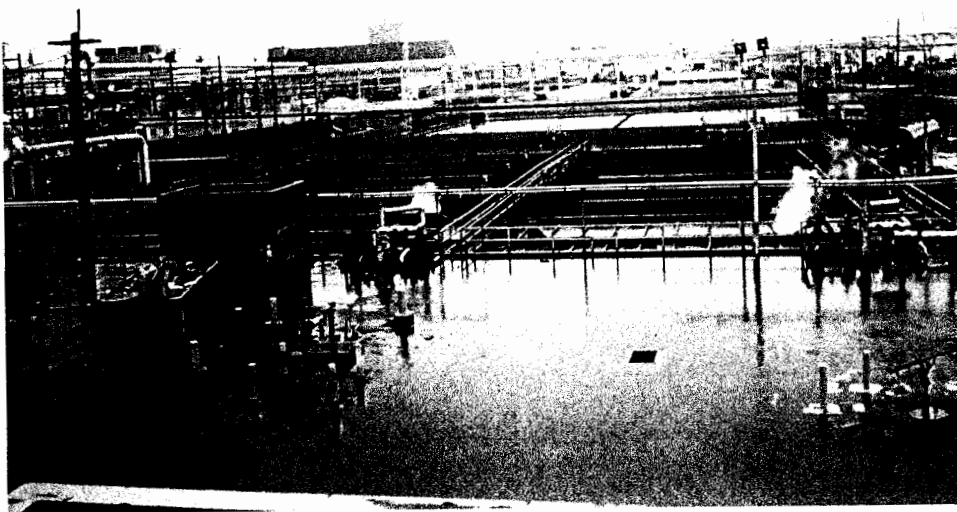
87.4-94.4 15 Oil/Water Separators. Overview facing east toward the separator. The Hazardous Waste Container Storage Pad (SWMU 22) is the large fenced concrete pad just beyond the separator.

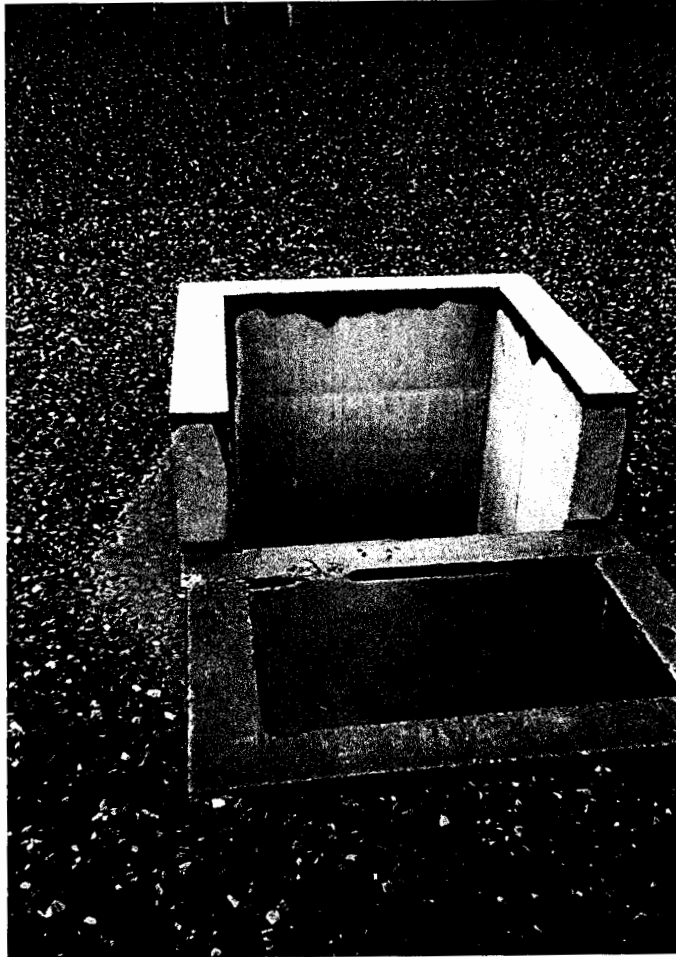
95.1

Combined Process/Storm Sewer System. View facing northwest showing a representative sump in the northeast Tank Farm located north of the FCC Unit.

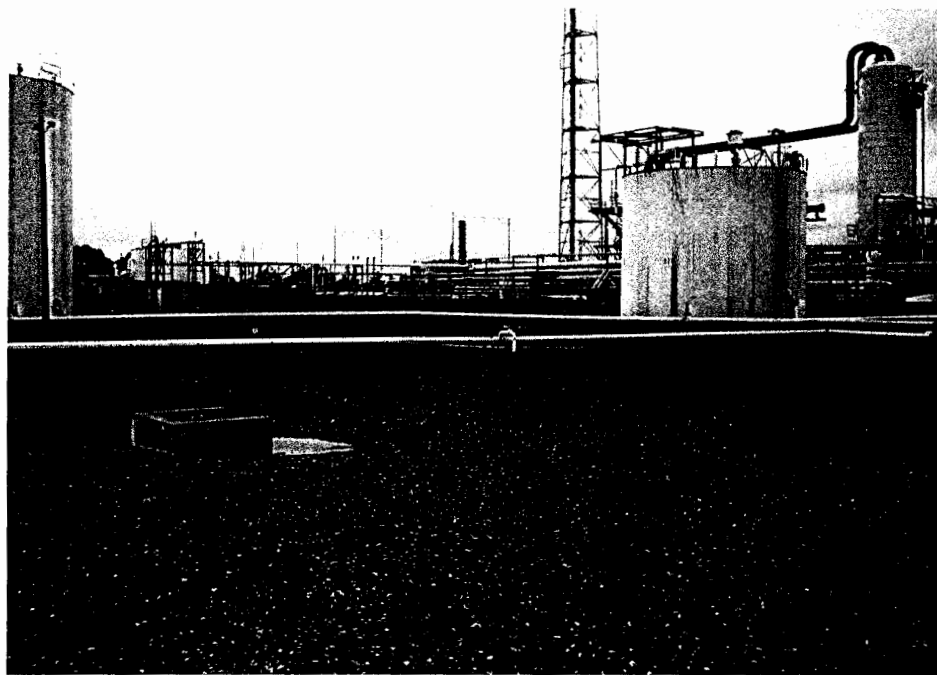
95.2 Combined Process/Storm Sewer System. View facing northwest toward the northeast Tank Farm shows four sumps for former tanks (one per tank) in the area. Each sump is controlled by a valve and discharges to the storm sewer pipeline.

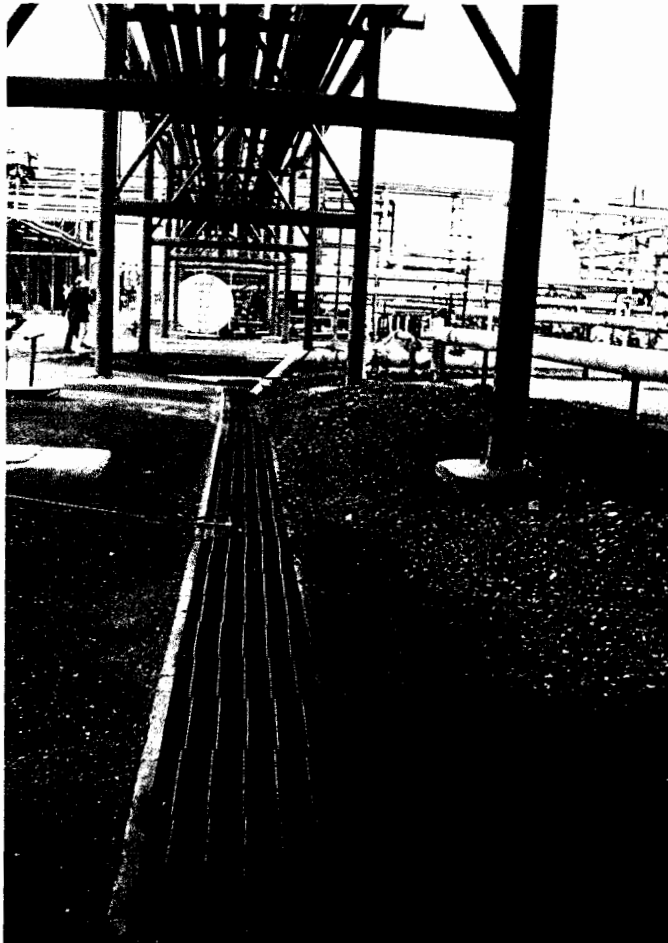
95.4 Combined Process/Storm Sewer System. View facing north showing the grated sump which runs along Hewes Avenue from the Tank Farm east of the 18 Plant.

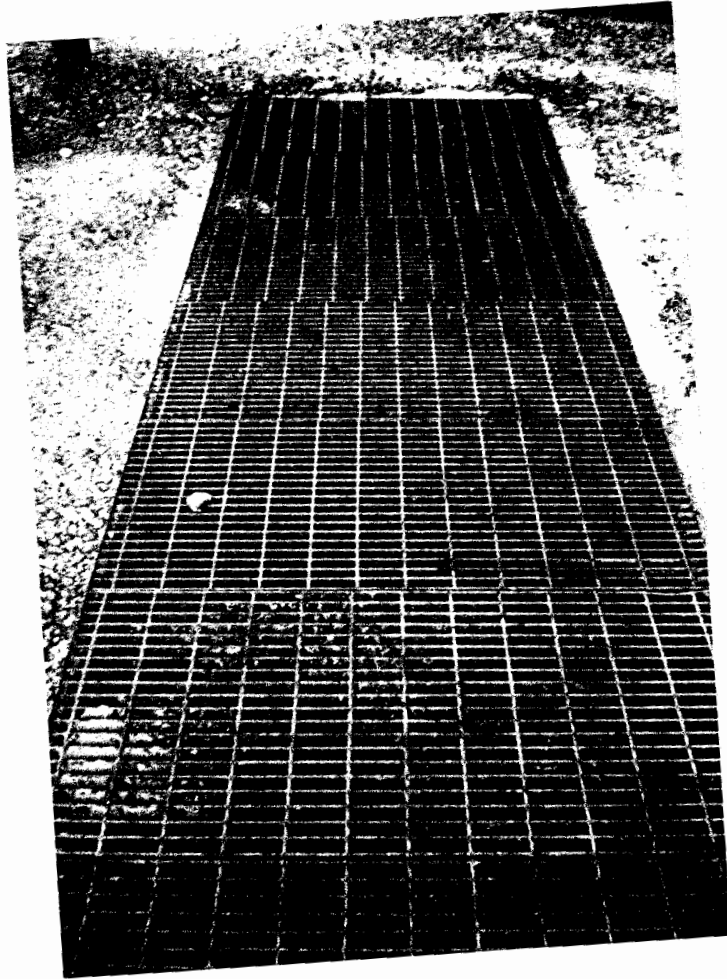
95.5

Combined Process/Storm Sewer System. View facing south toward old grated sewer box constructed of stone and brick (visible when grate was raised) in the vicinity of the Old 18 Plant Sludge Basin (SWMU 26).

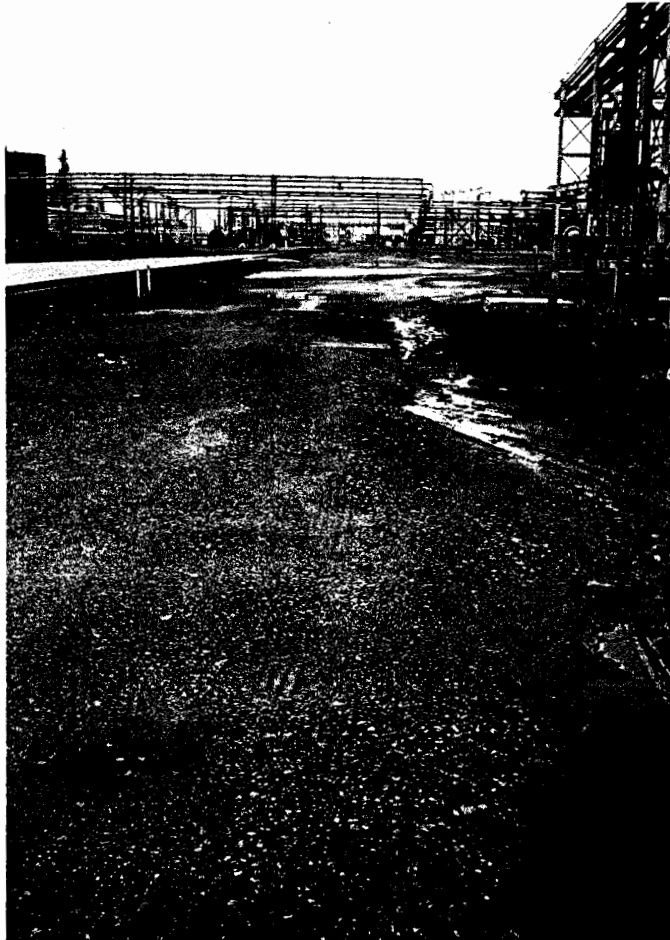
95.6 Combined Process/Storm Sewer System. View facing east along north side of the old 9 and 14 Oil/Water Separators (SWMUs 70-79) shows a large storm sewer drain and ditch.

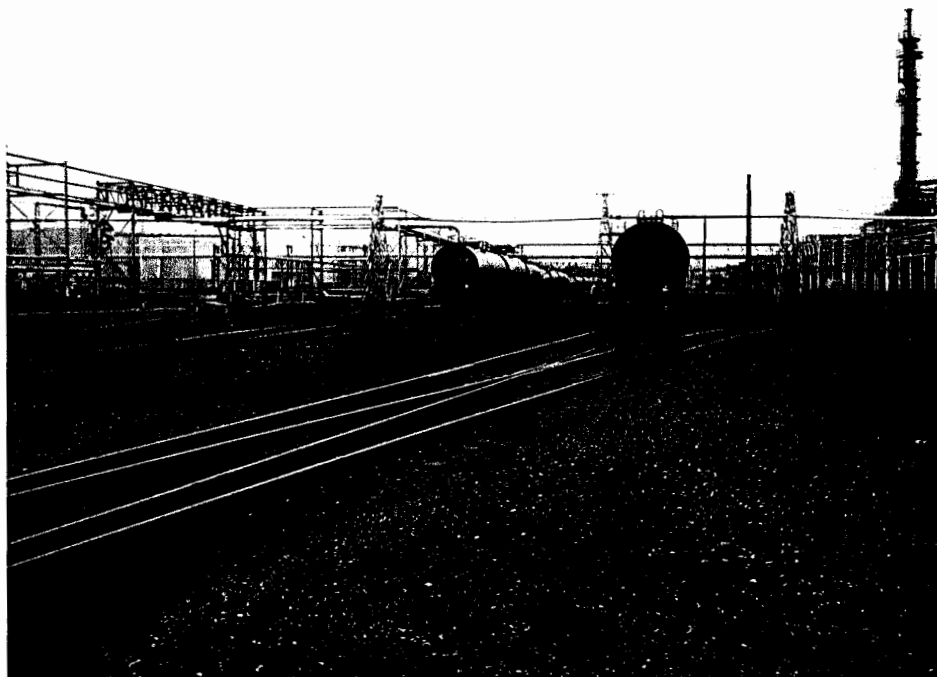
95.7 Combined Process/Storm Sewer System. View facing northeast toward the railroad tracks just south of the 16 Oil/Water Separators (SWMU 84-86) where several sewer drains are visible in the depressions (arrows). Staining is apparent around the drains from sewer backup.
